Restoration Plan for the South Branch of the Sandy River in Phillips, ME

Prepared for
Town of Phillips, ME

Prepared by
John Field
Field Geology Services
Portland, ME

January 2025

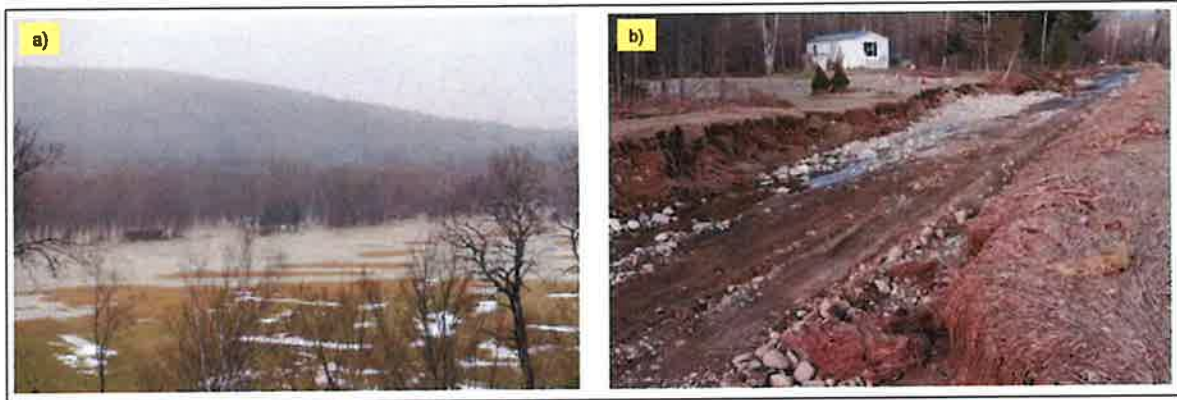
Figure 2. Flooding on the South Branch of the Sandy River in December 2023 a) inundated much of the floodplain surface and b) carved a new channel along the Number 6 Road. (Photos courtesy of landowner.)

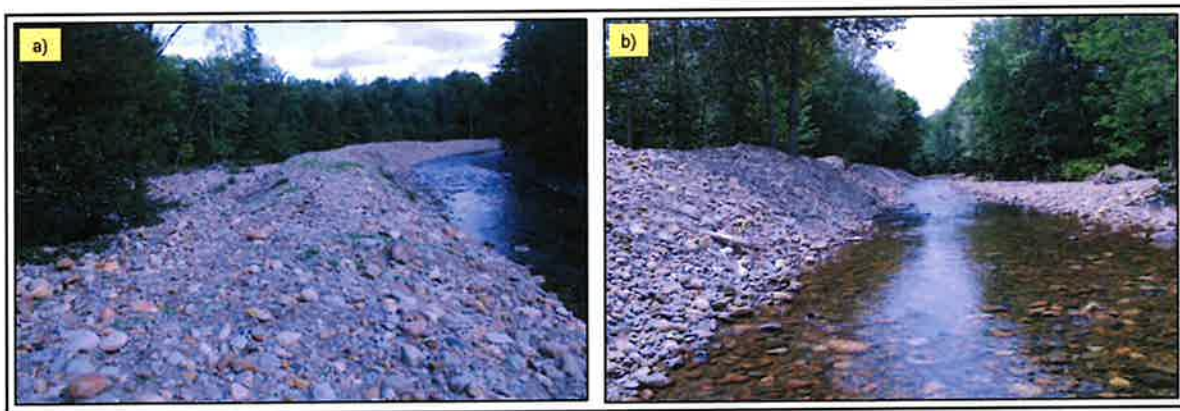
Figure 3. Post-flood emergency repair work in December 2023 included the construction of berms a) in the center of the channel and b) along the margins of the channel (both views looking upstream).

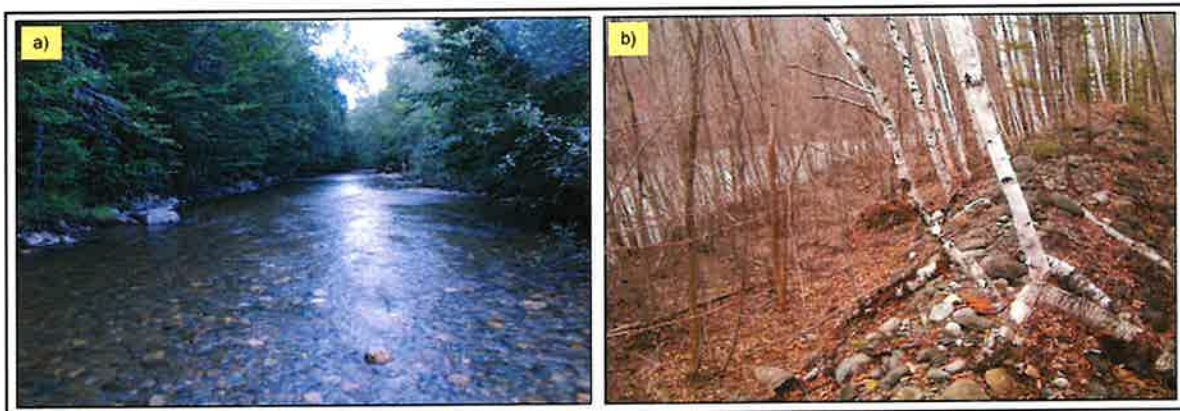
Figure 6. Long sections of South Branch (even where no emergency work occurred in 2023) a) remain in a straightened condition and, in places, b) have older berms built along them that further constrain the channel.

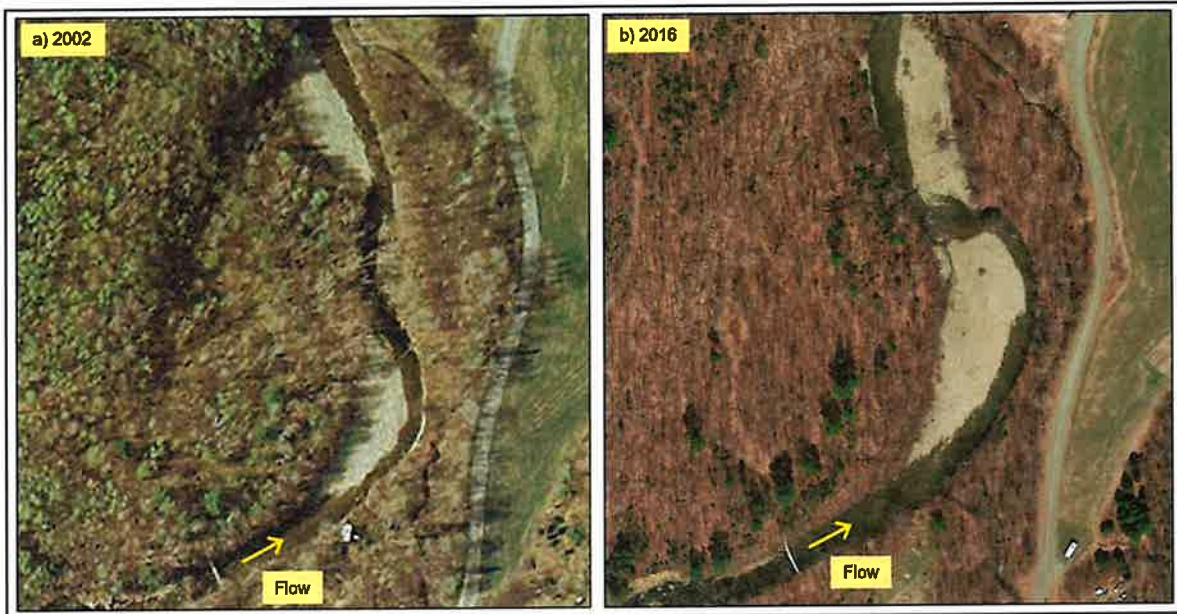
Figure 7. Rapid growth of gravel bar causes meander reformation between a) 2002 and b) 2016 at downstream end of straightened reach at Rollins/Tooker Site.

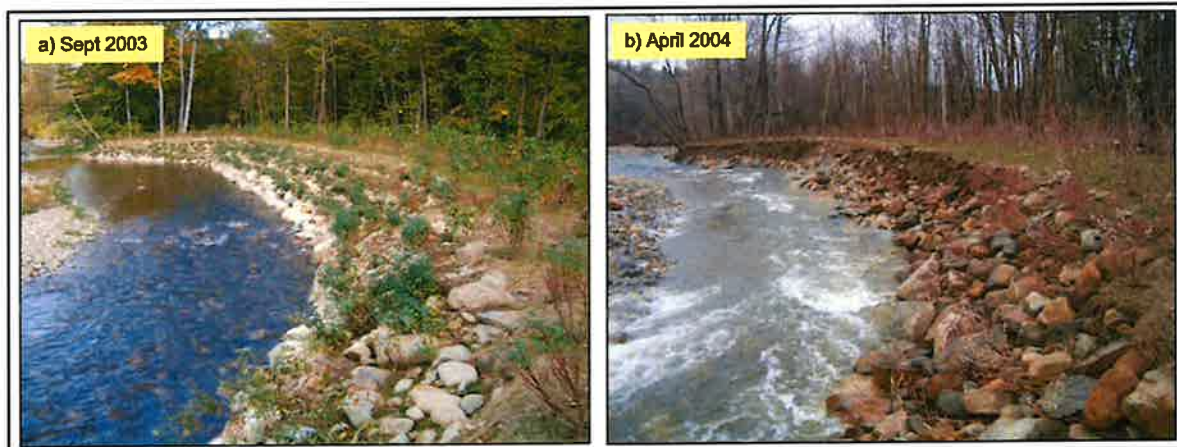
Figure 8. The dynamic nature of the South Branch illustrated by a bank stabilization project completed in a) September 2003 but damaged by b) April 2004 (due to a moderate flood in December 2003).

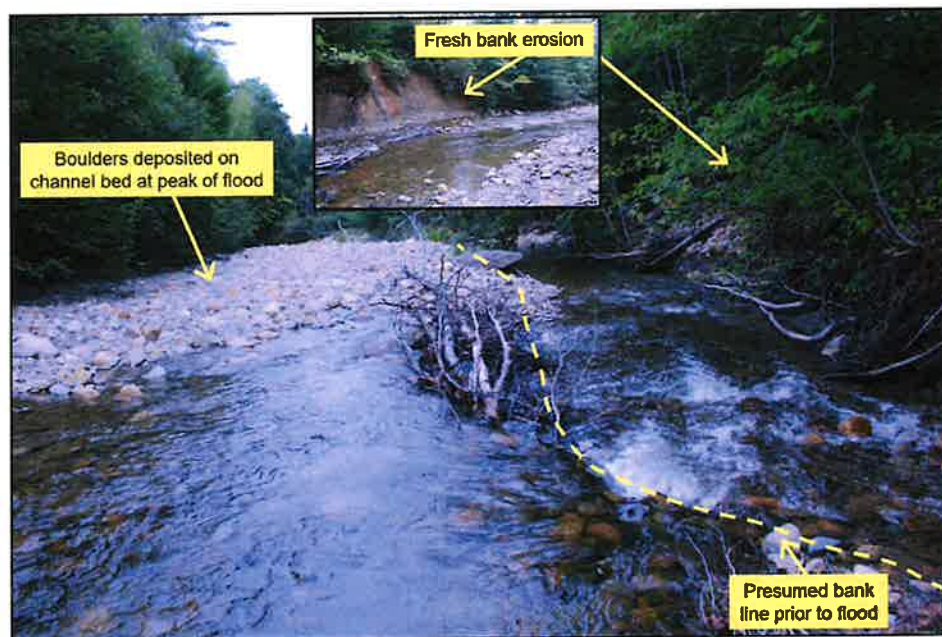
Figure 10. Boulders deposited on channel bed caused channel to shift (to the right) into high bank of finer sediment as flood receded. View looking downstream. (Inset photo looking upstream.)

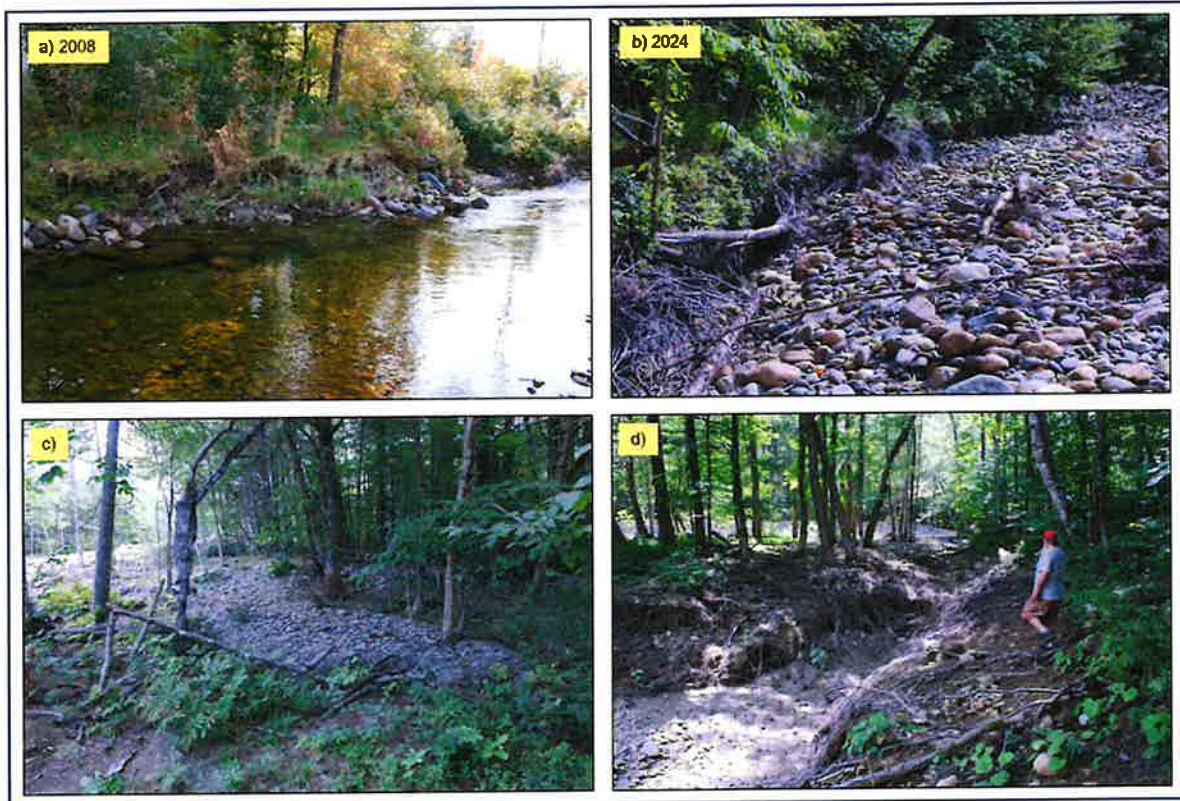
Figure 11. Evidence for the channel infilling with sediment during the December 2023 flood includes a decrease in bank height in the same area between a) 2008 and b) 2024, c) gravel tongues deposited on the floodplain, and d) formation of a new side channel with headcut (to the left of standing person) approaching main channel.

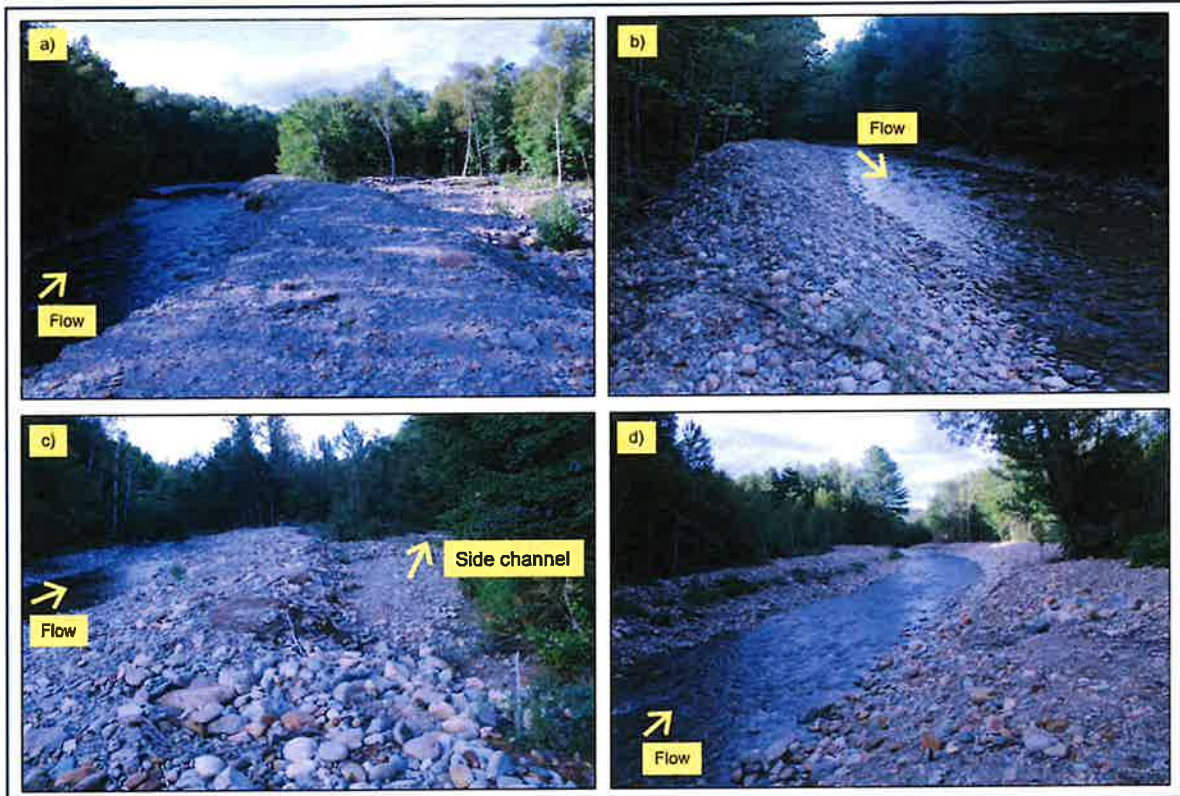
Figure 14. Four berm types constructed in December 2023: a) “in channel” berm (Rollins Site), b) “on floodplain” berm (Bennett Site), c) “blocking side channel” berm (Langdon Site), and d) “gravel veneer” berm (Langdon Site).

Re-grading of the berm material at the four sites will remove constrictions to flow, unblock side channels, and reestablish the complex flow patterns that create excellent habitat conditions for Atlantic salmon and brook trout. Topographic surveying results established the location, type, and volume of berming (Table 1 and map of berms and side channels in Appendix 1) and were used to determine how redistributing the berm material would alter the morphology and depth of the channel at each site (Figure 20). The “gravel veneer” berms at the Langdon Site will not be removed given that they are thin and not hindering overbank flows. All other berms will be regraded with the material to be redistributed within the bankfull limits of the channel, most to be placed on the channel bed but some used to recreate a point bar (at the Rollins Site) or placed on a mid-channel island (at the Hutchinson Site). Some additional excavation will be required at the Hutchinson Site and Rollins Site to reestablish pre-flood flow patterns.

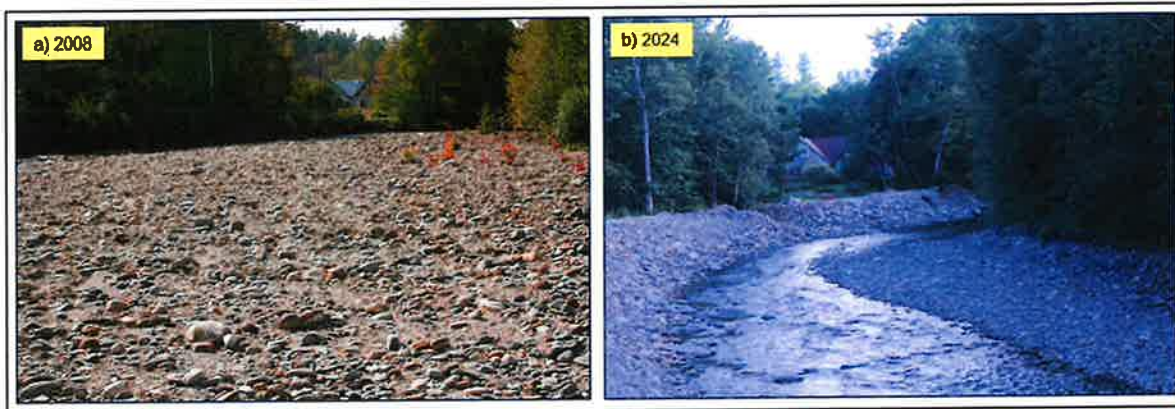
Figure 16. Photos from the same location looking upstream at the Rollins Site in a) 2008 and b) 2024 showing how large cobble point bar was excavated to form new channel and adjacent “in channel” berm.

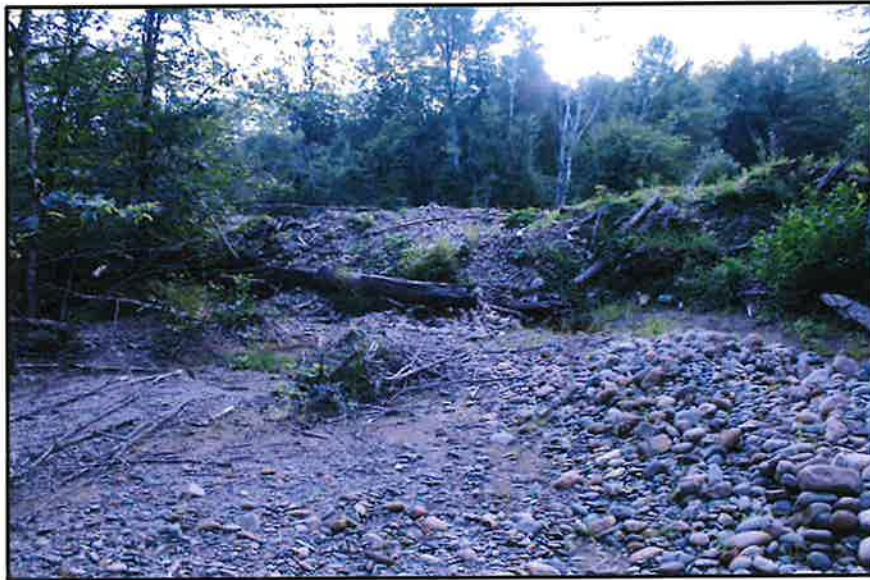
Figure 19. Entrance to low-flow side channel blocked by berm at Bennett Site.

channels are active even during baseflow conditions, channel-spanning log jams will be constructed just downstream of side channel entry points in order to slightly elevate the water surface. The loss of transport capacity as the flow bifurcates into numerous side channels at the Bennett Site led to large wood accumulations recorded in previous habitat surveys (see wood loading map in Appendix 1). Wood loading was much higher prior to the December 2023 flood at the Bennett Site compared to the other three sites, but now very little wood is present in the channel (Figures 14b and 15).

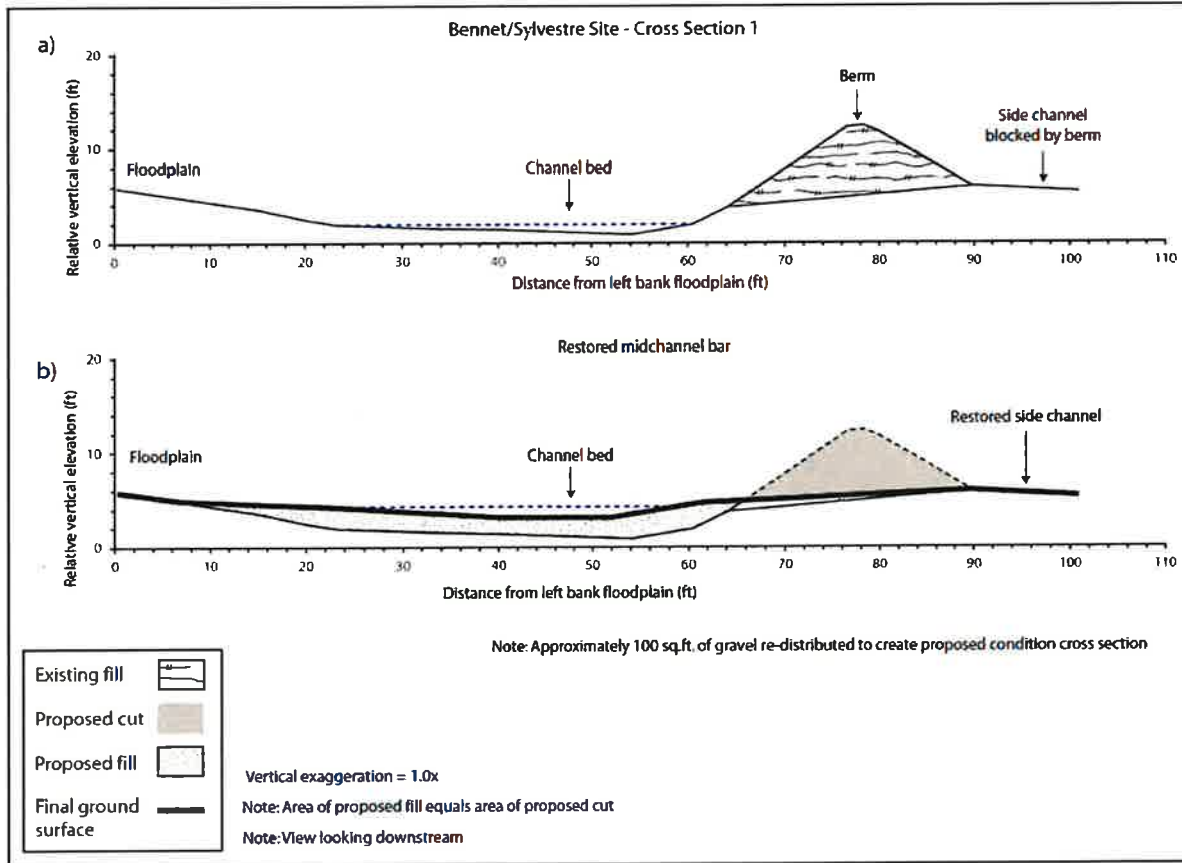
Figure 20. An example from the Bennett Site of how topographic cross sections were used to show the redistribution of berm material in the channel. Similar cross sections for all sites available in Appendix 1.
