Restoration Plan for the South Branch of the Sandy River in Phillips, ME

Prepared for
Town of Phillips, ME

Prepared by
John Field
Field Geology Services
Portland, ME

January 2025

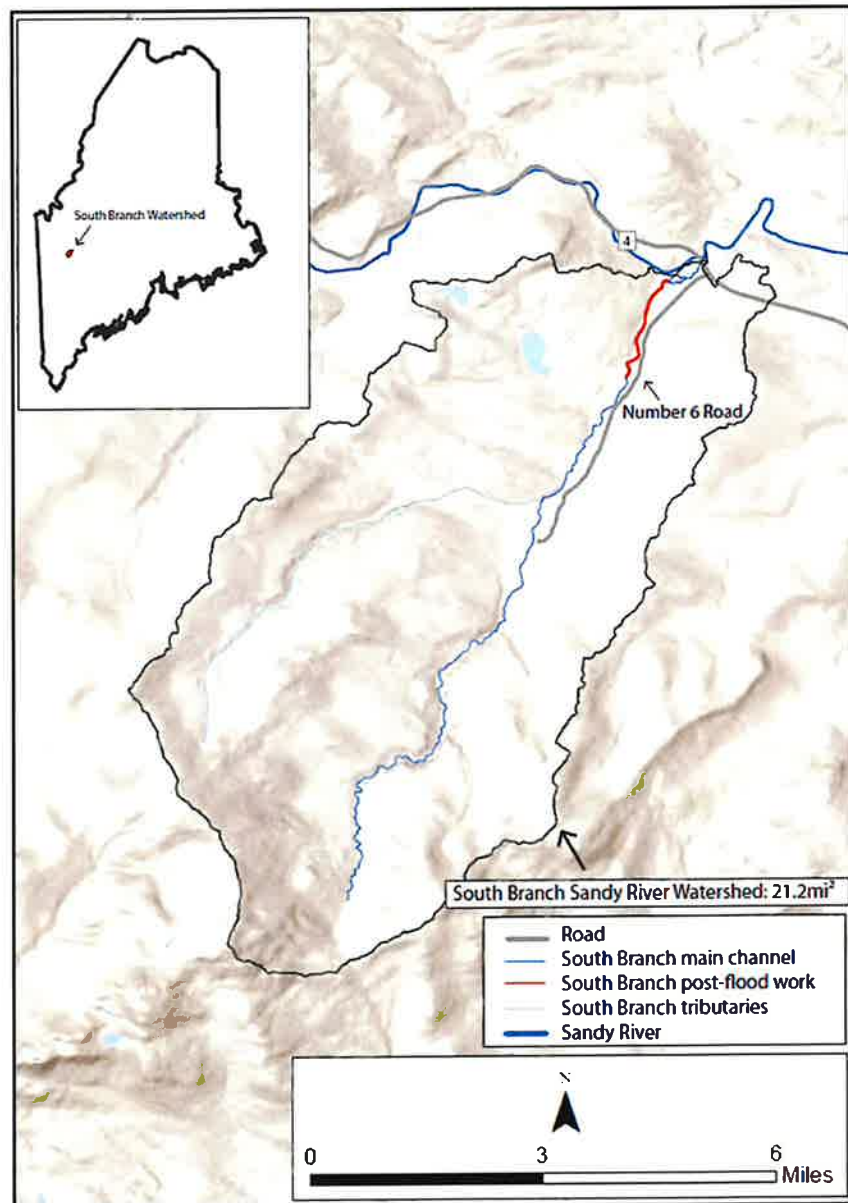
Figure 1. Watershed map of the South Branch showing the location of the post-flood repair work in Phillips, ME.

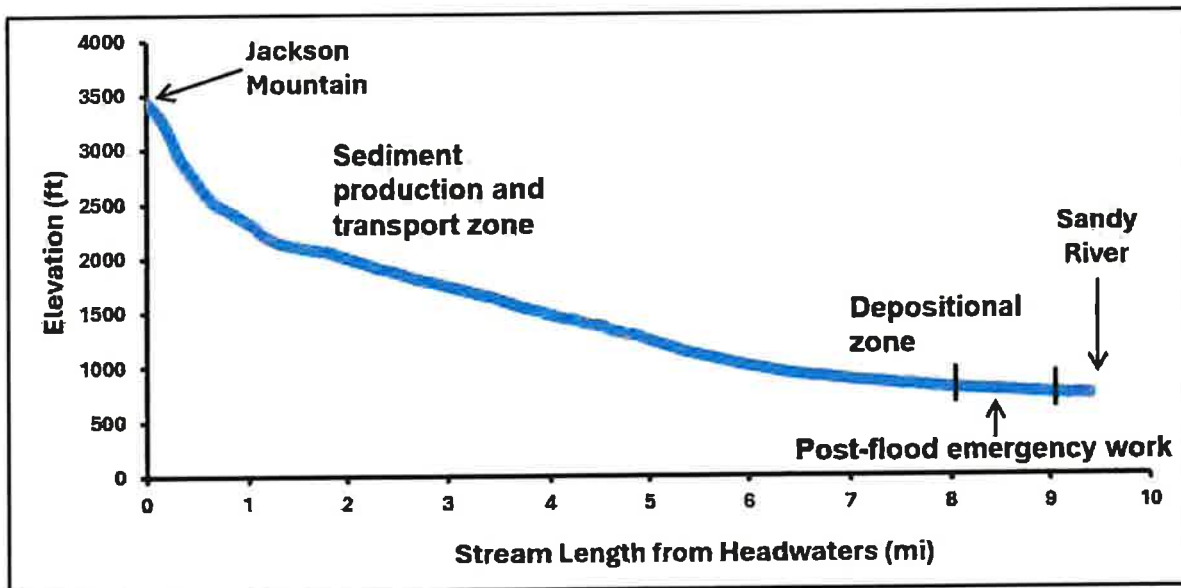
Figure 4. Longitudinal profile of the full length of the South Branch drawn from Google Earth data showing steep upper reach where sediment production and transport occurs and gentler lower reach where deposition occurs. Post-flood emergency work in December 2023 occurred in depositional zone.

Considerable sediment (and wood) production occurred in the upper South Branch watershed during the December 2023 flooding as would be expected in the steep confined terrain (Figure 4). Observations made along the 0.5 mi of the South Branch upstream of the post-flood emergency work reveal that large boulders were transported at the peak of the flood. As the flood receded, the channel shifted into one of the banks as the finer-grained bank materials were more readily transported than the boulders deposited on the channel bed (Figure 10). This process of the channel shifting off of the coarse boulder substrate into more erodible bank sediments was seen multiple times in the 0.5 mi reach of the upper watershed and resulted in significant sediment production and the loss of trees that were growing on the high banks prior to the flood.

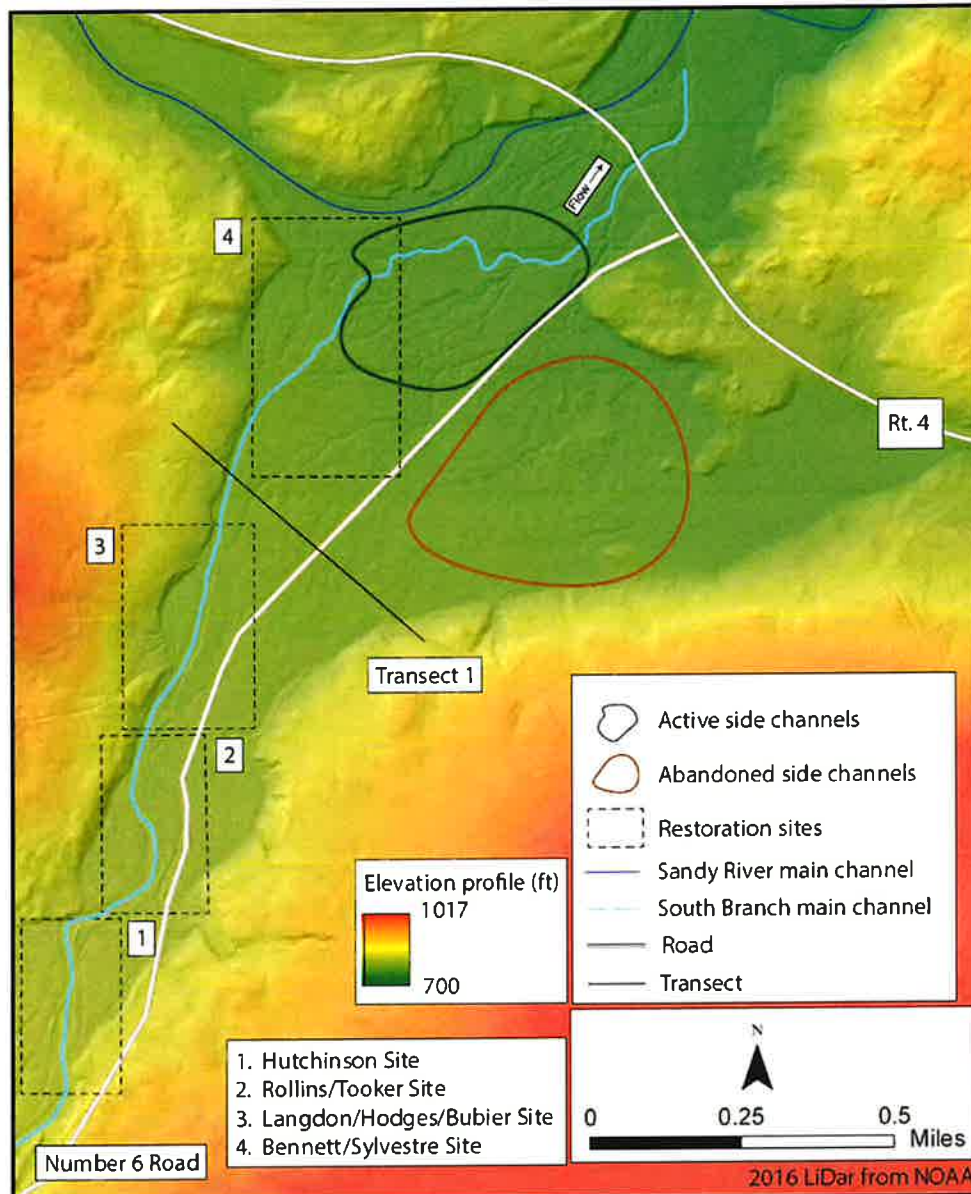
Figure 5. LiDAR imagery showing a complex network of active bifurcating side channels at the downstream end of the South Branch and vestiges of older inactive side channels across the entire unconfined floodplain, including east of the Number 6 Road where the main channel likely shifted periodically prior to human settlement. Four sites of post-flood emergency work and location of LiDAR generated transect also shown.

Under natural conditions, the main channel of the South Branch would be expected to flow anywhere across the wide flat unconfined floodplain (Figure 5). Currently, the South Branch flows against the western edge of the valley and has so since at least 1929 (Web citation 1), telltale evidence of channelization and artificial straightening associated with log drives (Field, 2007). Log drives did occur in the Sandy River watershed in Phillips back into the 19th century (Web citation 2).

The Number 6 Road, associated homes, and a railroad to the east extended up the South Branch valley by 1929 (Web citation 1) and must have altered flow into the now-abandoned side channels at the eastern edge of the floodplain (Figure 5). The channelization along the western edge of the South Branch valley was maintained by removing gravel, wood, and debris throughout much of the 20th century (as relayed through personal communications with multiple longtime Town residents). Despite these efforts, flooding in April 1987 caused damage, similar to December 2023, to the Number 6 Road. The damage resulted in a solicitation from the Soil Conservation Service (now Natural Resources Conservation Service) in 1987 for “obstruction and debris removal” along the South Branch (as revealed in documents stored in the Town office). The long lengths of South Branch that remain in a straightened configuration (Figure 6a) have a significant impact on geomorphic and ecological processes and increase flood, erosion, and channel migration risks. These conditions are enhanced where berms built along the edge of the channel in 1987 or before (Figure 6b) further constrain the channel.

The restoration will remain within the limits of the four discrete sites where post-flood emergency work was completed in December 2023 (Figure 5 and Appendix 1) and will focus on: a) re-grading of berms and b) restoring Atlantic salmon and brook trout habitat. The restoration intends to remove the constraints (i.e., berms) and add the structure (i.e., wood and boulders) needed for the full natural recovery of geomorphic and ecological function, so will essentially target a return to conditions that existed prior to the December 2023 flood. The restoration plan (Appendix 1) is summarized in the following sections below on the: 1) location of the restoration, 2) methods of restoration, and 3) timing and other details of the restoration.

The restoration will be conducted within the limits of the four discrete sites of post-flood emergency work in December 2023 (Figure 5 and Appendix 1). Impacts to side channels, for example, blocked by the berming will be only passively restored by removing the constraining berm but work further down the side channels will not be completed. Timely restoration is essential (see Section 5.3 below) as revegetation of the blocked side channels over a period of years will lead to more permanent changes that could no longer be reversed through passive restoration alone. Each of the four sites of restoration have particular site-specific conditions, briefly described below, that will control access to the site, restoration targets, and construction methods. All four sites are on private land, so landowner permission will be required before implementing the restoration work.

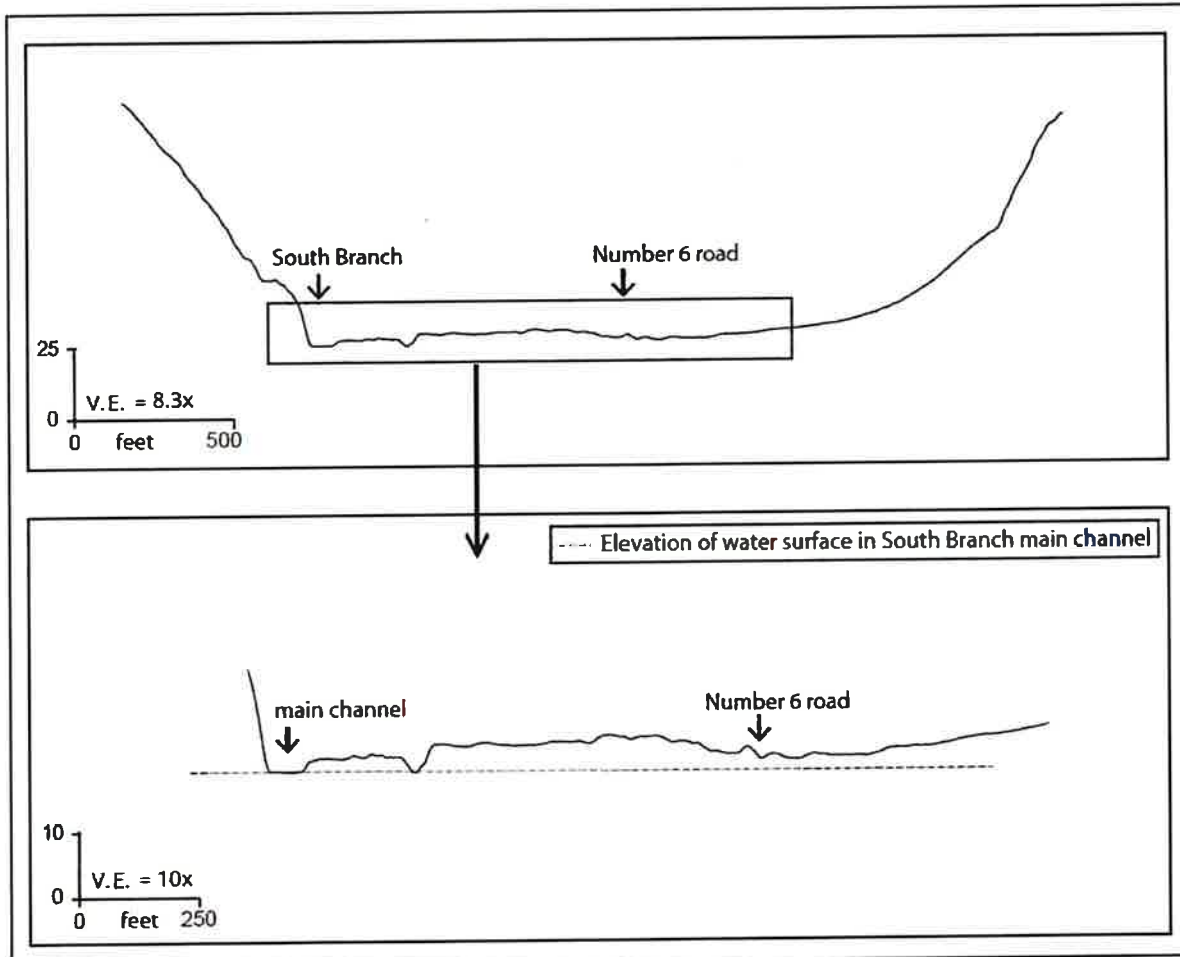
Figure 9. Transect drawn from LiDAR data showing main channel with low banks and side channels on the flat floodplain surface at nearly the same elevation as the main channel, highlighting the risk of a channel avulsion during a large flood. See Figure 5 for transect location. Bottom figure is area within box of top figure.

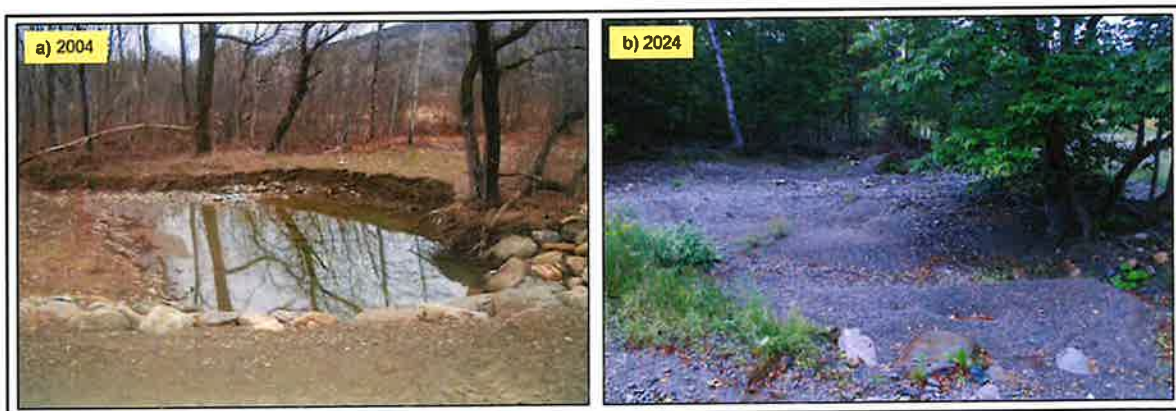
the road alignment (Figure 2b). Significant deposition also occurred on the floodplain surface, completely infilling a portion of one side channel (Figure 12). Extensive deposition on the floodplain, including east of the Number 6 Road, may have been enhanced by backwatering due to simultaneous highwater on the Sandy River given that most of the deposition occurred further downstream rather than where the flow first escaped the South Branch channel.

Figure 12. Photographs from the same location in a) 2004 and b) 2024 document the infilling of a side channel by sediment deposited during the December 2023 flood.

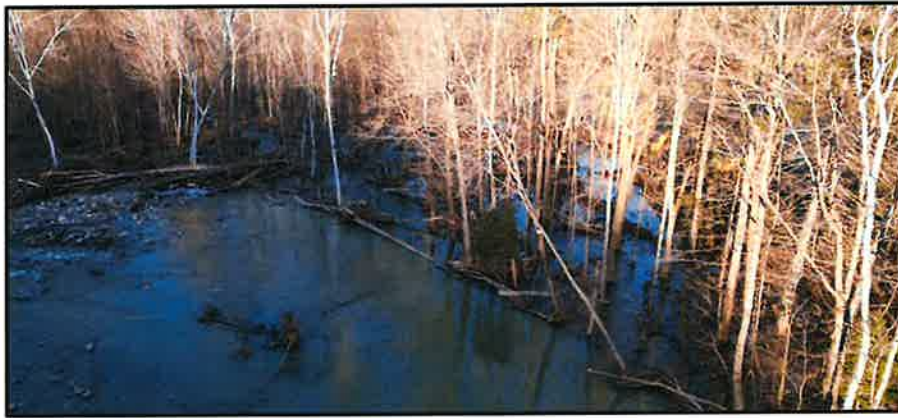
Town officials first arrived on the South Branch as the flood was receding with the main channel blocked by log jams and the Number 6 Road serving as the primary flow path for floodwaters spilling out of the main channel (Figure 13). If no post-flood emergency work had occurred, flow would likely still be concentrated along the road alignment as the new channel carved along the road was probably deeper than the infilled South Branch (Figure 2b). Flow along the Number 6 Road would likely bifurcate over time into numerous side channels across the fields and lower areas east of the road (Figure 9). The new channel system would look much like the pre-flood channel with numerous interwoven side channels resulting from significant deposition, but would differ in that no forested canopy would shade a channel flowing through open fields.

Figure 13. Floodwaters escaping the South Branch through the woods towards the Number 6 Road during the December 2023 flood. (Drone photo courtesy of the Town.)

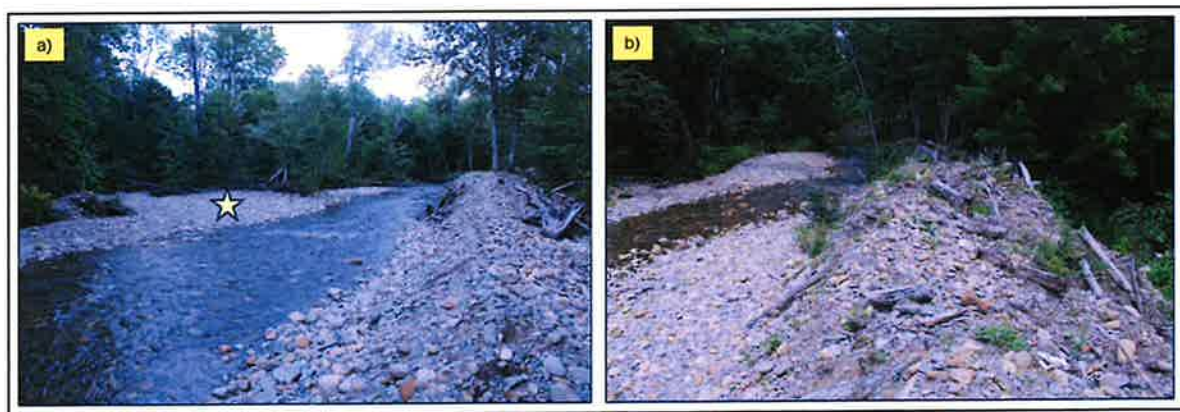
Excavation in the channel to form the berms returned the channel to the pre-flood depth but not deeper. At the Bennett Site, an unblocked side channel is just barely higher than the excavated main channel (Figure 15a). In addition to gravel, considerable wood was also removed from the channel (Figure 15b). The logs in Figure 15b were likely part of a log jam just downstream of the side channel and would have elevated the water surface enough to maintain flow in the side channel at baseflow. Excavation at the Rollins Site created a channel across what was a large unvegetated cobble point bar (Figure 16), shifting the channel’s position but not increasing its depth.

Figure 15. Entrance to a) a side channel (star) upstream of b) logs in berm that were likely part of a nearby log jam.

Flow complexity created by wood and boulder structure is essential for high-quality Atlantic salmon and brook trout habitat. The post-flood emergency work in December 2023 removed a considerable number of boulders (see map of boulders in Appendix 1) and volume of wood (Figure 15b) from the channel. The future retention of wood in the channel, in the absence of restoration, will be limited by high-velocity flows generated by the constricting berms. The re-grading of the

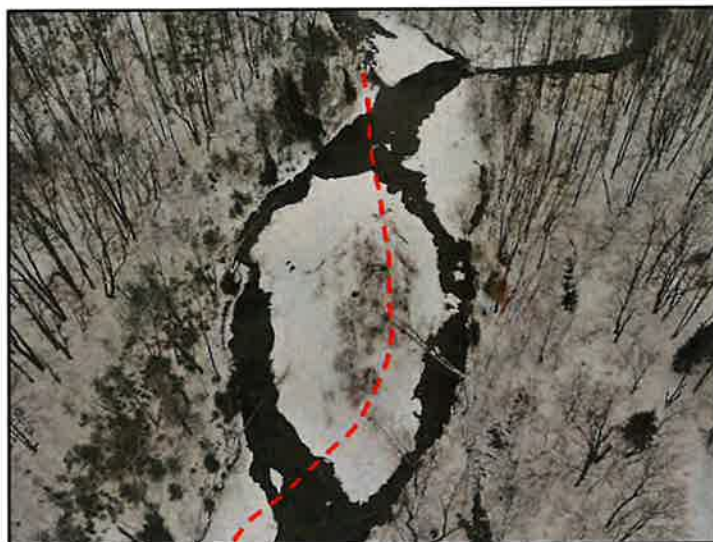
The Hutchinson Site will ideally be accessed through the driveway and back field of the Hutchinson property. The berm at the Hutchinson Site is largely within the bankfull channel, much of it built on top of a mid-channel island that existed prior to the December 2023 flood (Figure 17). Flow was split into two channels around the island prior to the December 2023 flood with all the flow now concentrated to the left side of the island (looking downstream) with the berm blocking flow to the other channel. Restoration of the site will restore flow to both channels around the island, requiring excavation of the now-blocked channel given the infilling of the channel that occurred during the December 2023 flood. The volume of sediment to be removed from the berms and excavated to reform the channel to the right of the island will be redistributed into the channel to the left of the island and on the island itself. This will raise the elevation of the island slightly while maintaining more depth in the channels in order to reduce overbank flooding, although continued deposition in the channel after restoration will increase that risk over time.

Figure 17. Drone image of Hutchinson Site prior to December 2023 flooding (courtesy of landowner) showing split flow around mid-channel island. Dashed line shows approximate position of “in-channel” berm. Upstream view.

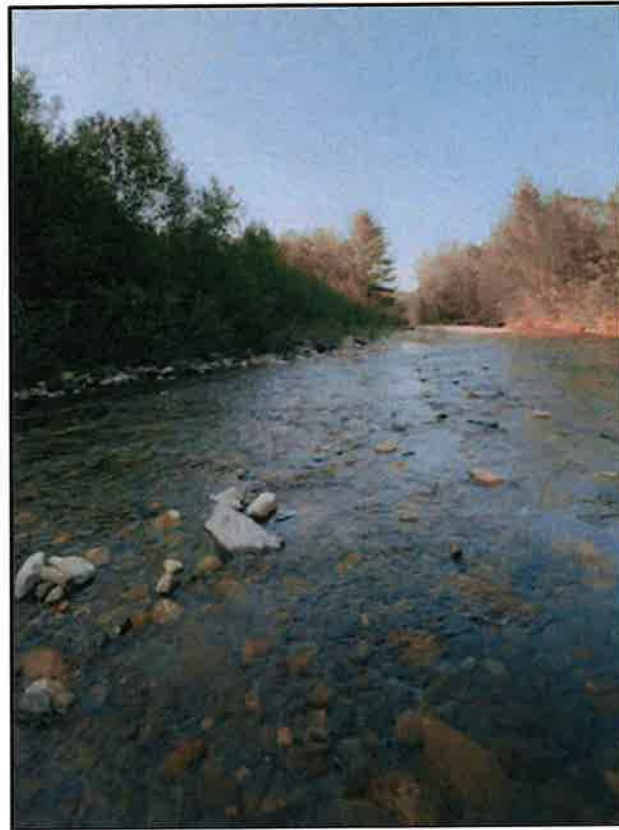
improving the canopy but is not part of the restoration plan as further landowner permission would be required. The Langdon Site is an artificially straightened section of the channel that was constrained by “on floodplain” berming along the left bank, blocking a high-flow side channel. A “blocking side channel” berm on the right bank prevents flow from entering a low-flow side channel. The re-grading of these two portions of elevated berm will remove the recently placed constraints on the channel but the straightened configuration, in which little wood was being retained prior to the December 2023 flood (Figure 18 and wood loading map in Appendix 1), will remain.

Figure 18. Photo of Langdon Site prior to December 2023 (courtesy of landowner) showing its straightened alignment and lack of wood retention.

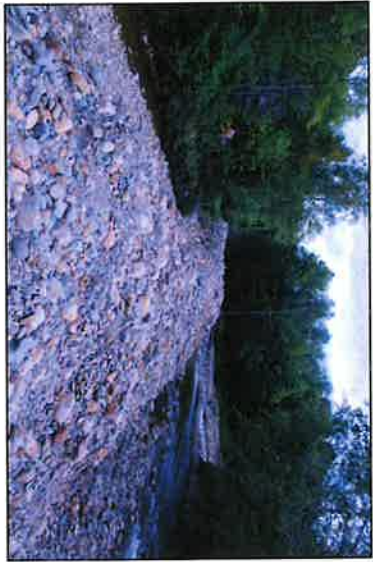
Hutchinson Site - portion of project area (upstream view)

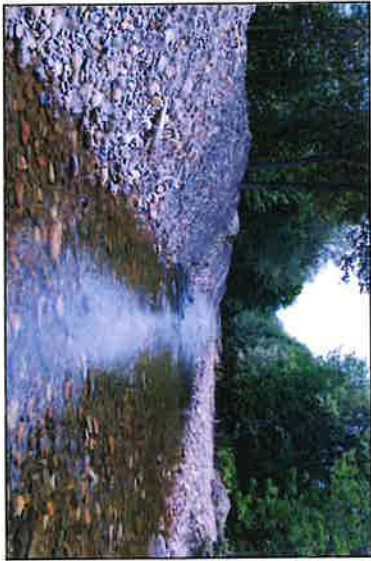
Bennett/Sylvestre Site - portion of project area (upstream view)
